IMECE2009-10498

THE RIGOROUS APPLICATION OF FMEA TO A WASTEWATER TREATMENT PLANT AERATOR DRIVE: UNDERSTANDING REQUIREMENTS, CONDITIONS, LIMITATIONS AND SUCCESS FACTORS

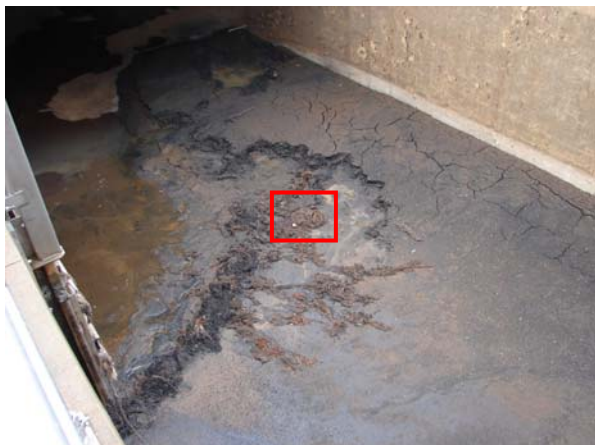
In October 2008, Aerator 1 was replaced with the new heavy-duty drop bearing design. A visual inspection of the tank showed a build up of sediment. Refer to Annex D Figure 6-7 for Photos. The sediment was found to be different than in Aerator 2 tank. This sediment appeared to be mixed with a fibrous textured debris in approximately 20% of the sediment. Again, the impeller was checked for runout and balance. The impeller inspection revealed an imbalance and fractured blade tips. Annex D, Figure 8. A counter weight was added to one of the blades to bring the impeller into balance. Annex D, Figure 9. During the same trip, the gearbox supplier inspected Aerator 2 unit, which had been operating continuously for 2.5 months. The unit temperatures and operation were all found to be within normal parameters. No seal leakage was observed. Aerator 1 unit was returned to the assembly plant for failure analysis.

Figure 6. Aerator 1 Basin Sediment

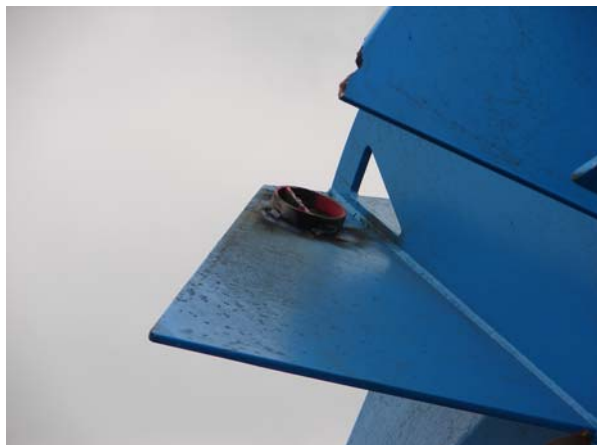
Figure 9. Added Weight to Re-Balanced Aerator 1

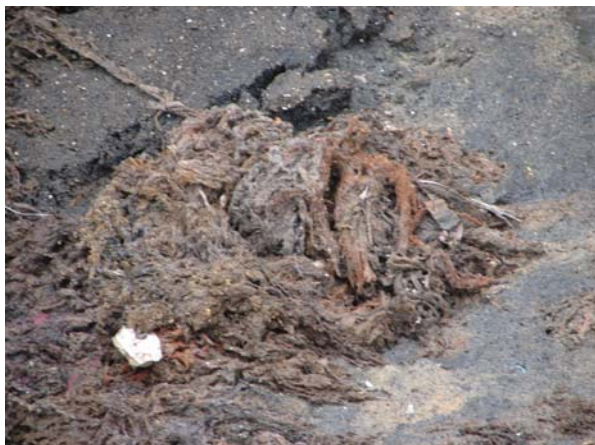
Figure 7. Detail of Fibrous Debris in Aerator 1 Basin

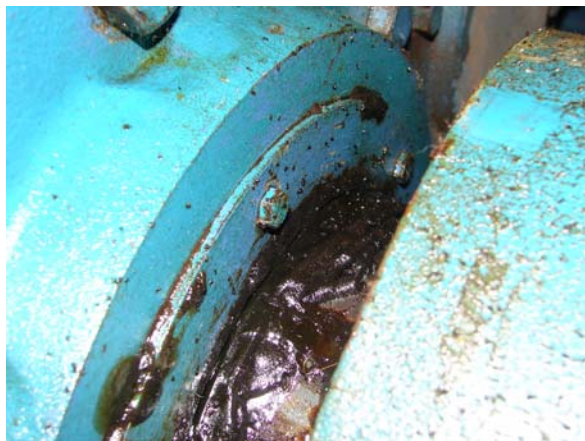
The remaining oil was drained from the gearbox, then nameplate information, low speed seal area and input shaft seal area were inspected. There was heavy grease leakage from the low speed shaft seal. The grease was discolored to black from the light green that was the original color. There was some rust on both low speed and input speed shaft but no significant damage was found. The shaft run-out and also endplay were within the specification. The shaft run-out on low speed shaft was actually 0.100mm and the shaft run-out on input shaft was 0.010mm.

Figure 10. Low Speed Seal Area at Factory Inspection

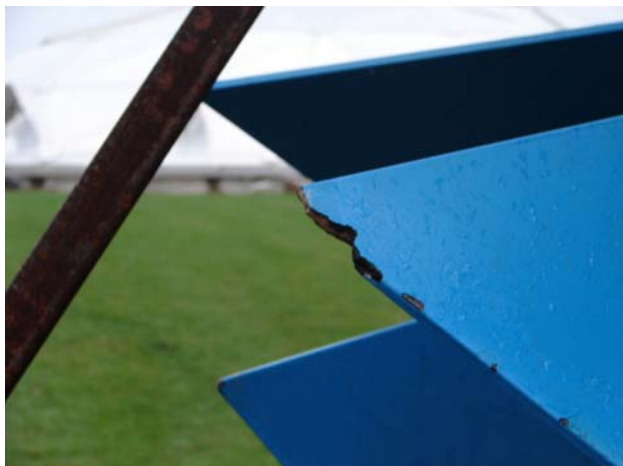
Figure 8. Example of Broken Impeller tip for Aerator 1

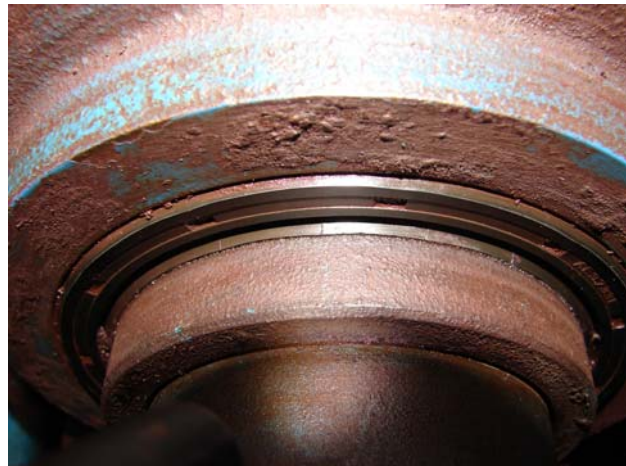
Figure 11. Input Shaft Seal Area at Initial Inspection

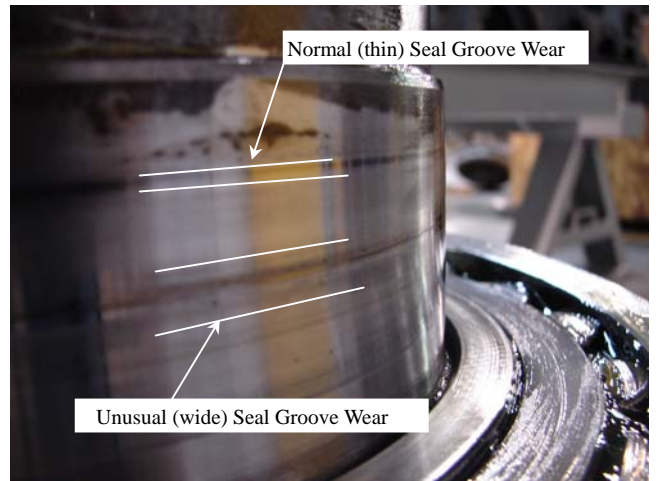
surface, LSS bearing, LSS oil seal and drywell baffle. The LSS had up to 5mm wear marks from the inner seal. The seal grooves, caused by seal wear on the LSS, were found to be acceptable. There was no other significant wear on the LSS at the bearing mounting. The QC Department independently inspected the shaft. All dimensions including runout were found to be within tolerance. The LSS oil seal where the grease came out did not have any significant damage such as softening or brittleness on the OD and lip. The OD of the seal had a dry ‘ring’, which is assumed to mean that no grease penetrated the seal OD. The QC Department also inspected the welding of the drywell baffle. No irregularities were reported.

Figure 14. Low Speed Shaft Seal Contact Area

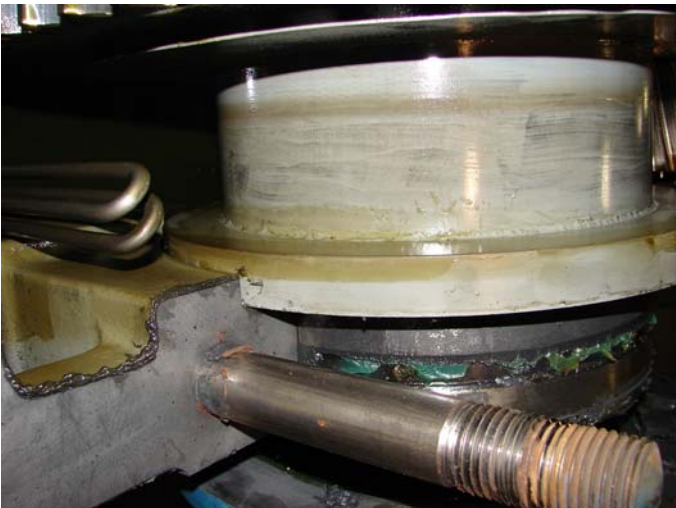
Figure 17. Drywell Chamber
