IMECE2009-10498

THE RIGOROUS APPLICATION OF FMEA TO A WASTEWATER TREATMENT PLANT AERATOR DRIVE: UNDERSTANDING REQUIREMENTS, CONDITIONS, LIMITATIONS AND SUCCESS FACTORS

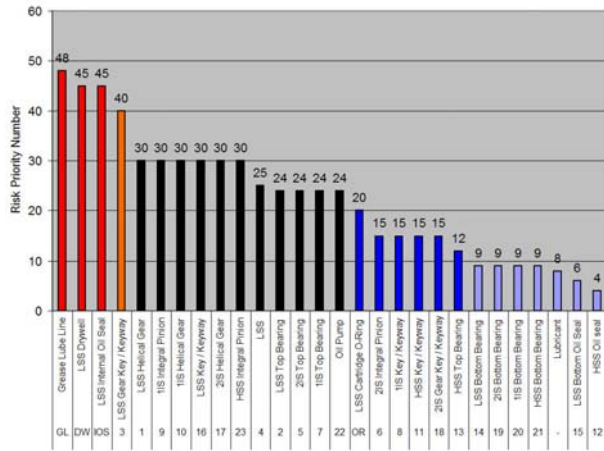
Chart 1. Risk Priority Number (RPN)

The calculation of the RPN ‘weighs’ the components in such a way as to identify critical components. In the gearbox supplier’s analysis, the Grease Lube Line, LSS Drywell and LSS Internal Oil Seal would be the top three as detailed in Chart 1.

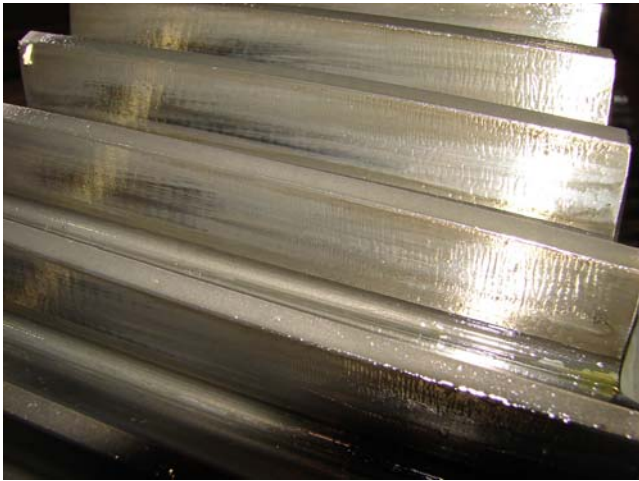
Figure 12. Low Speed Gear

After the external visual inspection, all external parts such as pump and piping were removed and the housing was disassembled for internal visual inspection. There was some slight wear on the gears, but all looked to be in good condition and no significant damage was observed. All bearings were found to be in good condition. After the internal visual inspection of the gears and input/intermediate bearings, the low speed shaft portion was disassembled in order to see the LSS

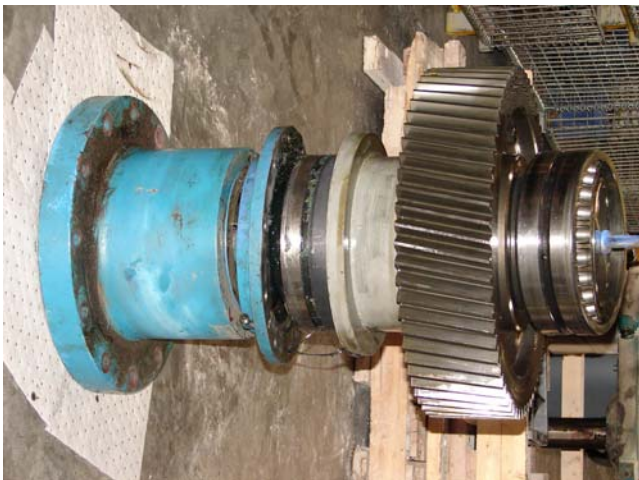
Figure 13. Low Speed Shaft Assembly

surface, LSS bearing, LSS oil seal and drywell baffle. The LSS had up to 5mm wear marks from the inner seal. The seal grooves, caused by seal wear on the LSS, were found to be acceptable. There was no other significant wear on the LSS at the bearing mounting. The QC Department independently inspected the shaft. All dimensions including runout were found to be within tolerance. The LSS oil seal where the grease came out did not have any significant damage such as softening or brittleness on the OD and lip. The OD of the seal had a dry ‘ring’, which is assumed to mean that no grease penetrated the seal OD. The QC Department also inspected the welding of the drywell baffle. No irregularities were reported.

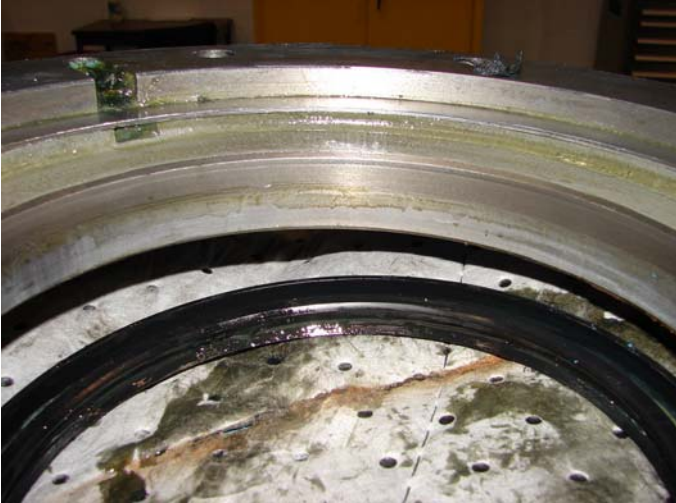
Figure 16. Low Speed Seal and Bearing Cover

The remaining oil was drained from the gearbox, then nameplate information, low speed seal area and input shaft seal area were inspected. There was heavy grease leakage from the low speed shaft seal. The grease was discolored to black from the light green that was the original color. There was some rust on both low speed and input speed shaft but no significant damage was found. The shaft run-out and also endplay were within the specification. The shaft run-out on low speed shaft was actually 0.100mm and the shaft run-out on input shaft was 0.010mm.
